**THE CALIFORNIA EARTHQUAKE OF APRIL 18, 1906**

**REPORT**

**STATE EARTHQUAKE INVESTIGATION COMMISSION**

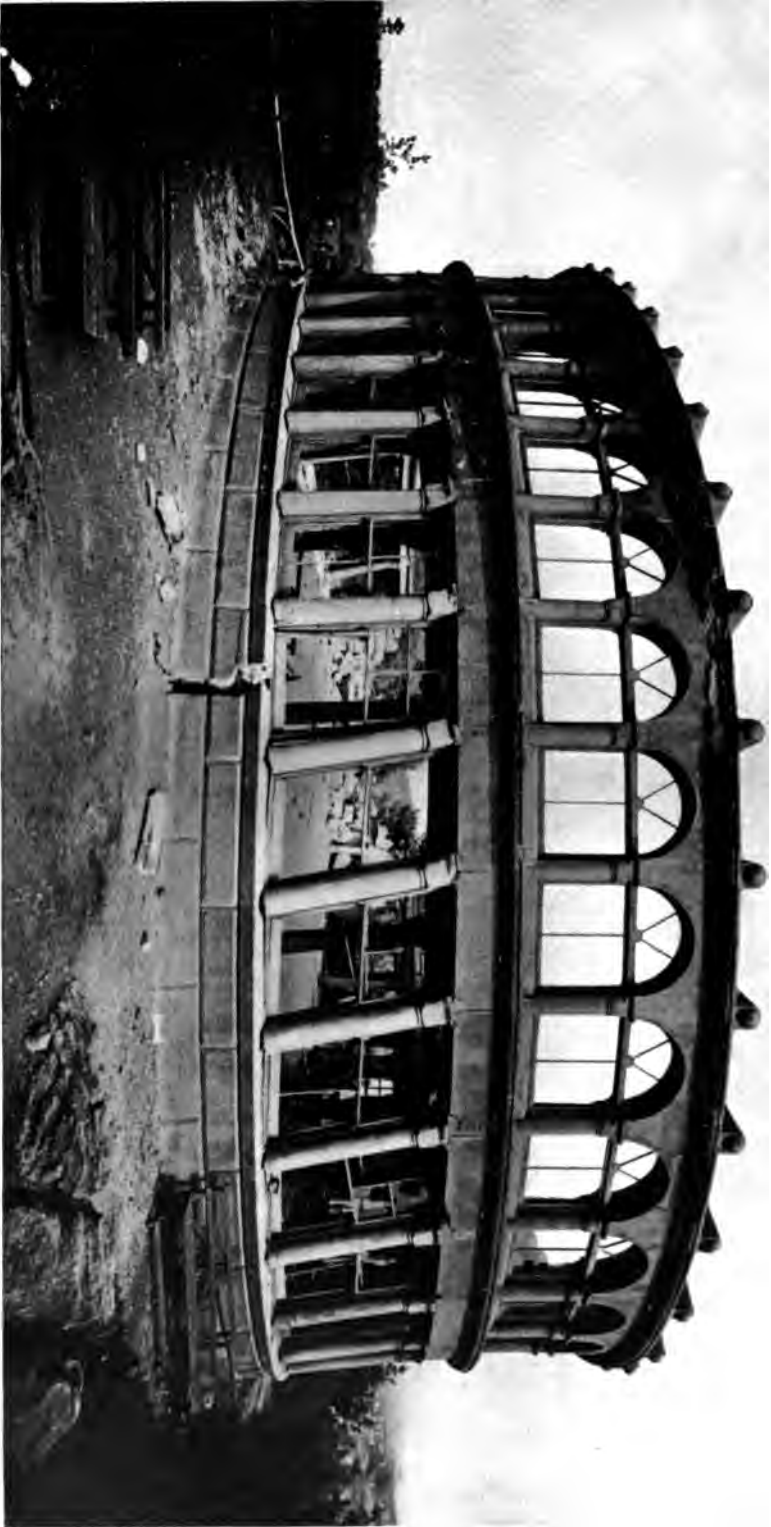
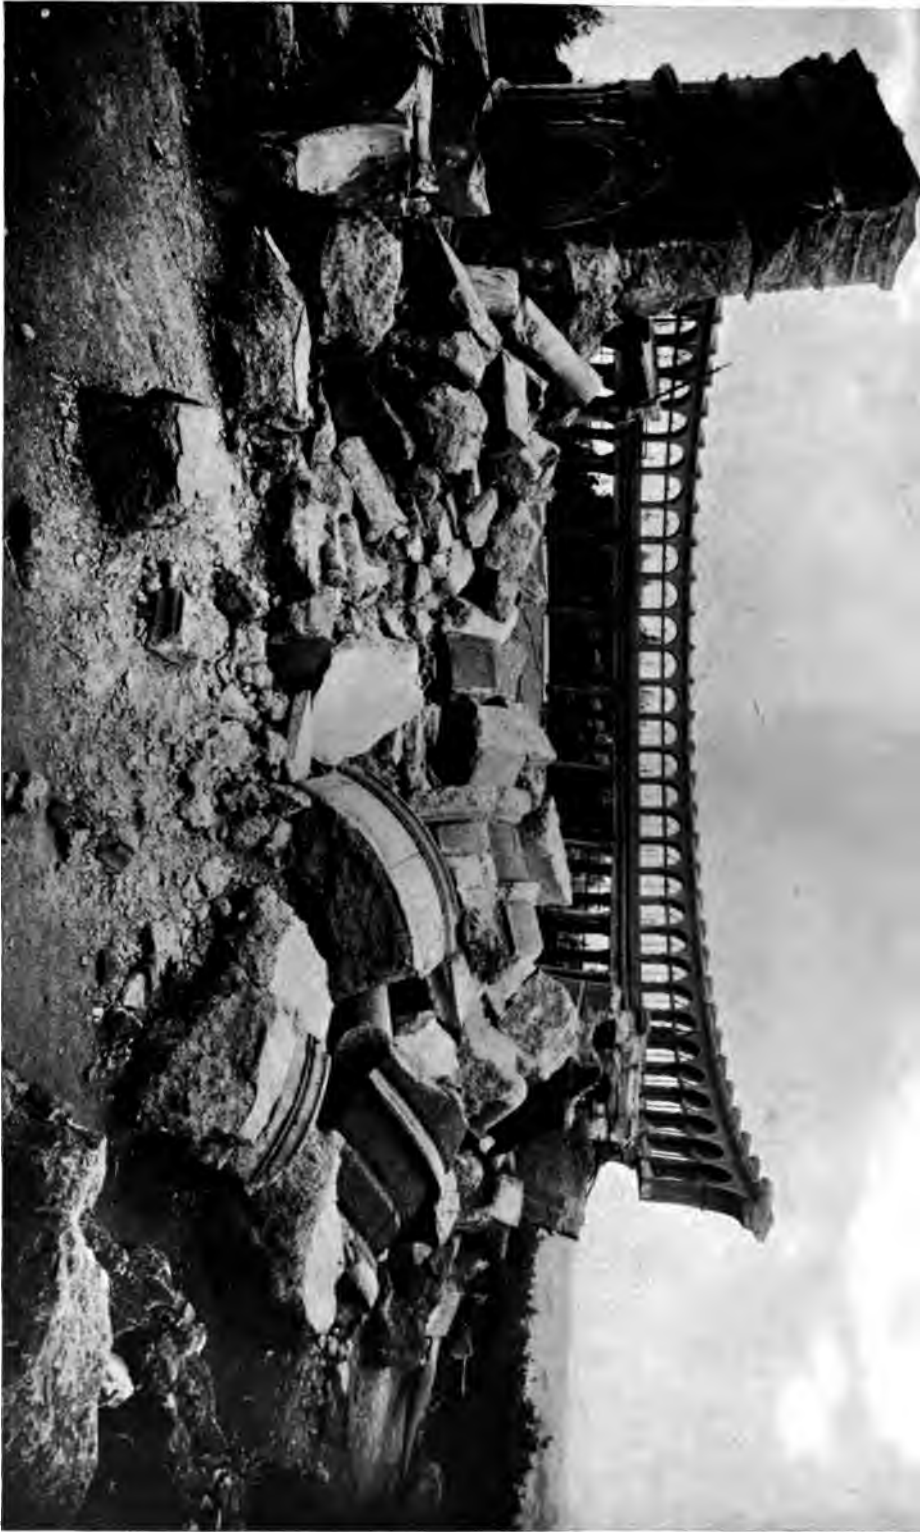
Observatory, Strawberry Hill, Golden Gate Park, San Francisco. W. L. Worden, Photo.

Observatory, Strawberry Hill, Golden Gate Park, San Francisco. W. E. Worden, Photo.

Strawberry Hill, in Golden Gate Park, is a chert knob rising abruptly in the sand wastes. Its summit had been leveled, but it is not known whether this was done by cutting off the top and filling out the upper slopes, or by filling alone. The altitude given for the present hill is the same as that given in the earliest accurate surveys. Much artificial stone work, and a circular concrete observatory building 2 stories high, had been erected upon the leveled hilltop. This building was of weak design, having a row of columns, with windows between, which rested upon a foundation wall 3 feet high and supported a heavy second-story balcony. The construction itself was probably good, but the observatory was utterly ruined by the shock. (Plates 84 and 85.) The entire lower story was sheared out of position, and part of the balcony fell. The cement floor showed numerous cracks arranged in a roughly concentric way.

The whole periphery of the hilltop was broken into a series of concentric blocks or steps, and the outer ones moved down the hill from 2 to 3 feet. The artificial stone work was badly cracked and dislodged. These phenomena indicated that the material used in grading the upper slopes had settled somewhat, with consequent rupture of the surface and wrecking of the building. No other explanation can be urged for such striking damage on this hill, in view of the small damage produced on other rock summits in the city.

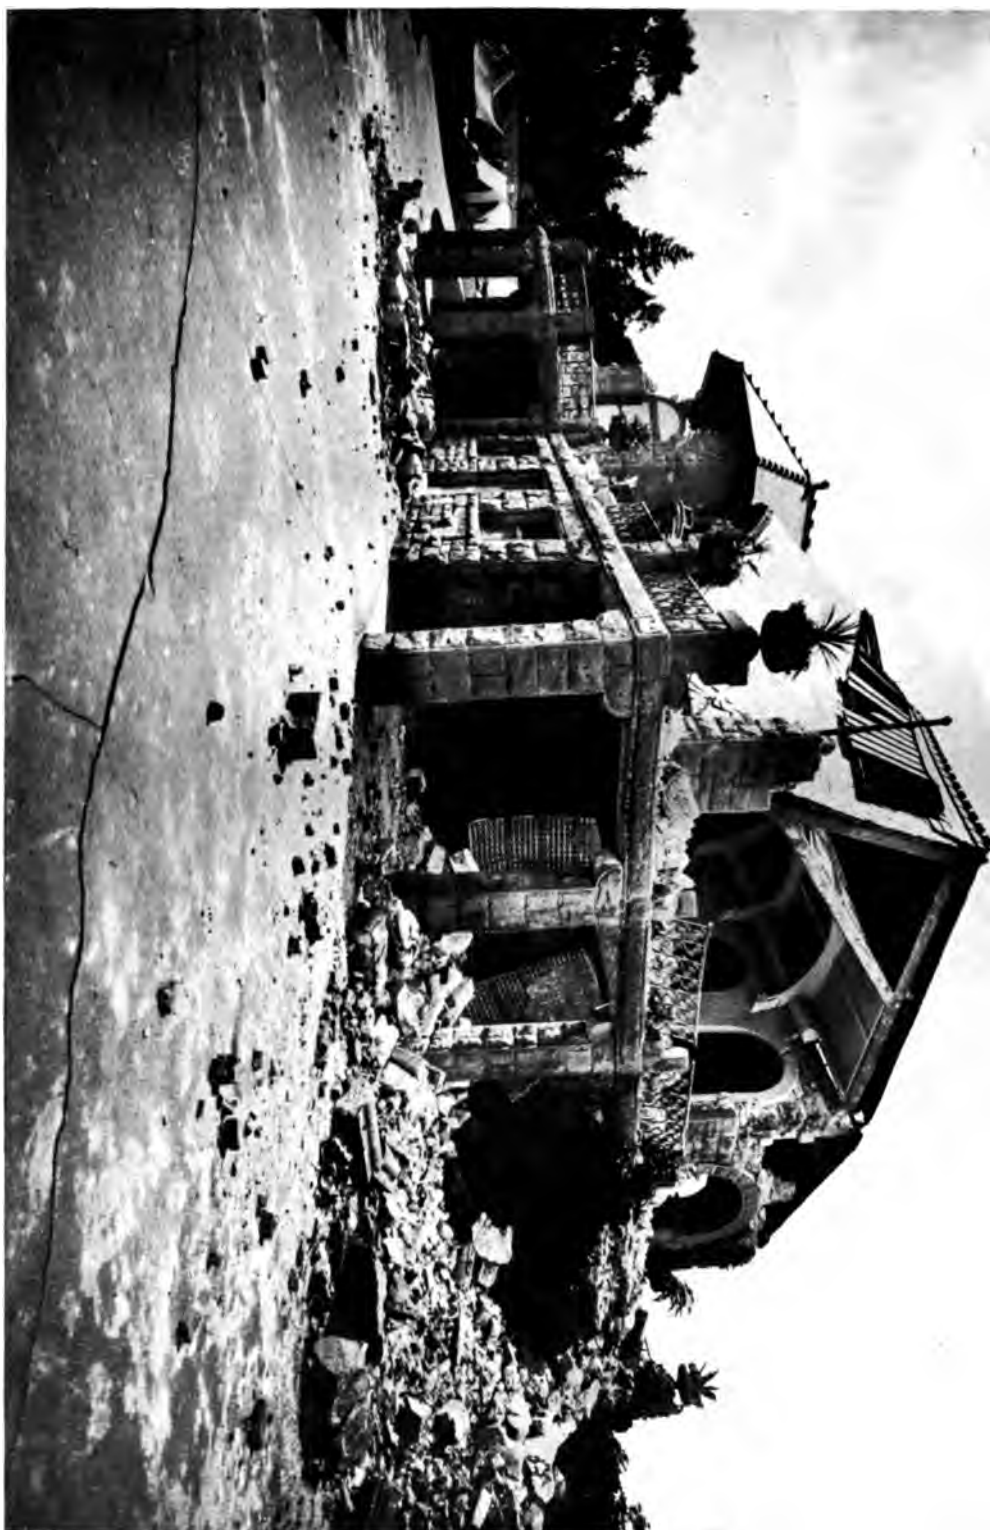
The Park Emergency Hospital, near the southeast corner of Golden Gate Park, had its walls badly cracked and its gable thrown out. It is a small, 1-story, sandstone building, with a wooden frame. Its site was loose sand of unknown depth, probably extensively graded. Evidently it was not an excellently built structure. The restaurant at the children's playground in the Park was wrecked. (Plate 86.)

Restaurant at Children's Playground, Golden Gate Park, San Francisco. W. E. Worden, Photo.

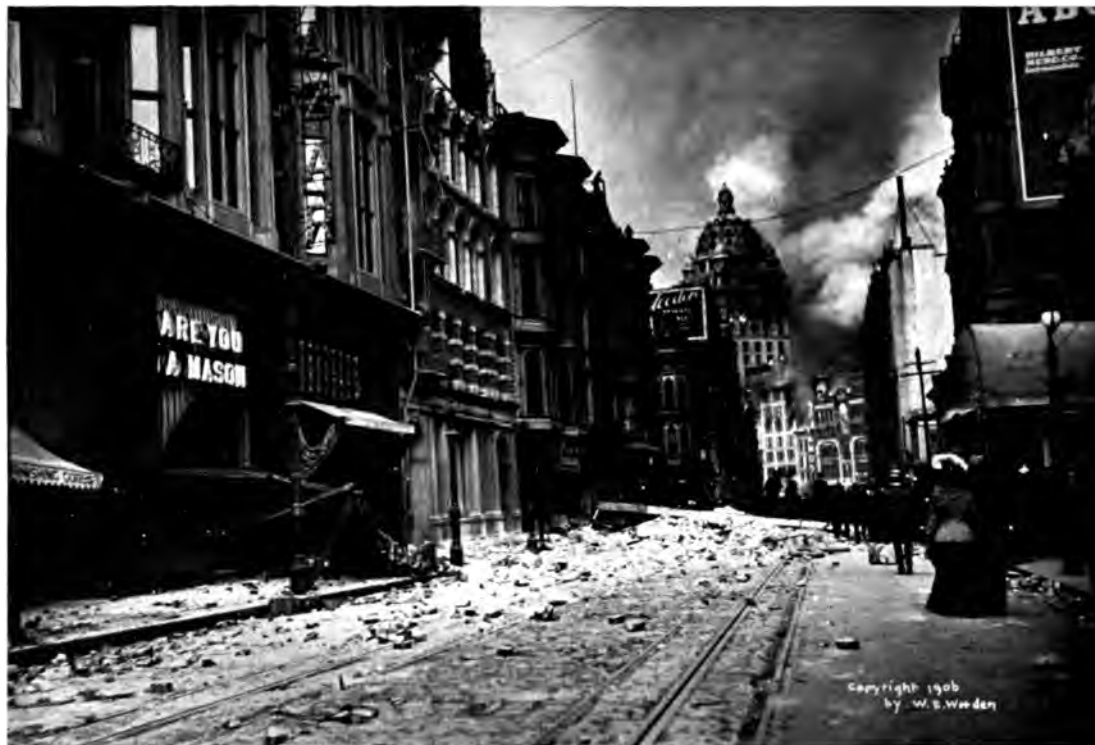
A. O'Farrell Street, San Francisco, after earthquake and before fire.

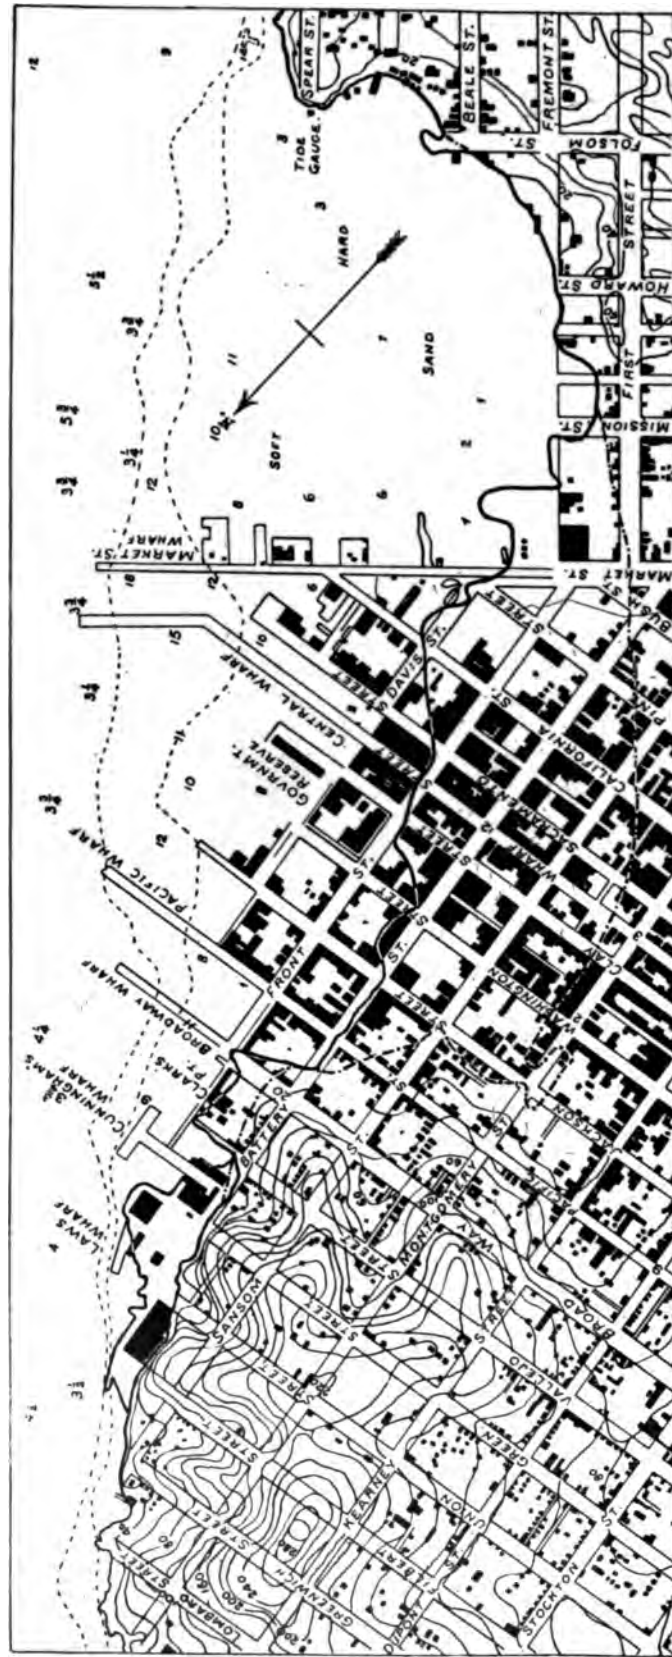
FIG. 51. — Map showing original high-water line of Eddy survey (dot and bar) and mean low-water line or "zero contour" (full line) for district about foot of Market Street in 1853. From Chart of Coast and Geodetic Survey.

It is of interest to inquire whether all or only a portion of this district in which high intensity was developed is "made" land. In the map (fig. 51) is reproduced a portion of the U. S. C. & G. S. chart, "City of San Francisco and its Vicinity," published in 1853 from surveys made in 1851-1852. On it the dot-and-bar line represents the course of the "original high-water line according to plot of Wm. M. Eddy's survey dated 1852." The "zero contour" which determines the configuration of the shore, except where wharves put out, is shown by a continuous line; it is not expressly defined, but it is believed to represent mean low-water, as the soundings are measured from this level. It is needless to point out that this contour is drawn farther seaward than the original high-water line. The portion thus delimited has an area of not less than 20 city blocks, partly or wholly occupied by buildings. Quite outside the "zero contour," as shown on this map, are 8 complete blocks and portions of others — an area of not less than 10 city blocks, partly or wholly built upon. If, then, confidence may be placed in the location of the original high-water line of the Eddy survey of 1852, there were already in San Francisco 30 blocks of "made" land, occupied wholly or in part by buildings before the end of 1853, less than 4 years after the sudden rush to California which followed the discovery of gold in 1849. The revised chart of 1857 shows that very little additional land was made in this district in the succeeding four years.

Without conflicting evidence from other surveys, and no such evidence has been found, the high-water line established by the Eddy survey can not be discredited. Still it is proper to state that these facts raise some doubts as to the accuracy of its delineation, and that the evidence developed by the earthquake does not tend to dispel these doubts. The gradation in the effects produced by the shock, from great magnitude at the waterfront to small at the former land margin, would suggest that at least the marginal district where only Grade C intensity was developed, tho outside the location of the original high-water line, might not be made land, altho it has undoubtedly been somewhat elevated by grading. Very little stress can be laid on this suggestion, however, for these districts suffered very severely in the earthquake shock of 1868; but the materials used in filling were then, of course, shaken together, and in addition, the slow settling together from year to year has undoubtedly compacted the earlier made land much more than that recently "made." Besides, the exhibition of damage depends upon the character of the structures in a given locality, as well as upon the ground, and it is to be noted that the buildings along Kearney, Montgomery, and Sansome Streets comprized a larger percentage of excellent structures than the streets nearer the wharves. The problem is thus complex, and very likely unsolvable; but there remains the haunting suggestion that the "original high-water line" does not constitute the landward boundary of the "made" land, properly speaking. At any rate, it is very clear that that which was known to be "made" land suffered much more severely than that which was known to be natural alluvium.

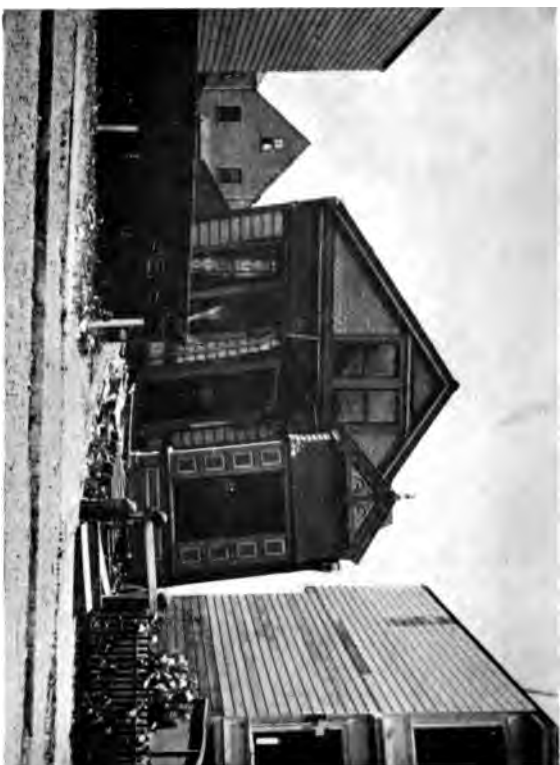
A. Frame building on west side of Eleventh Avenue, just south of California Street, San Francisco. A weak structure, built on sand. H. O. W.

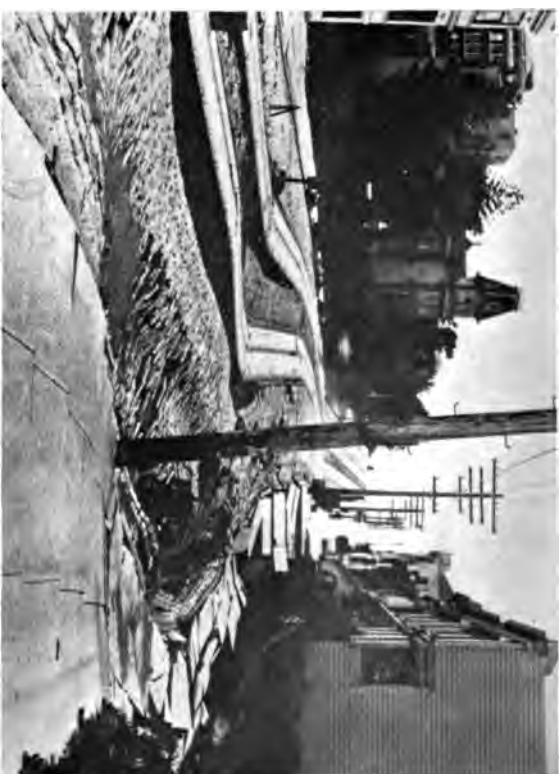
B. Slip of a fill on Union Street, just west of Steiner Street, San Francisco. H. O. W.

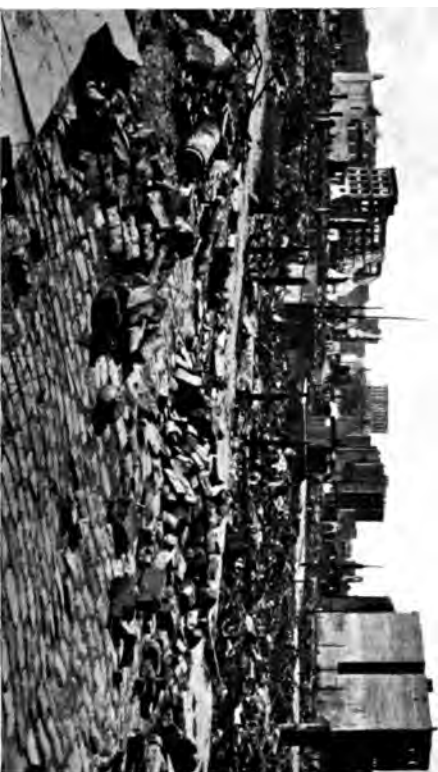
C. Bus Street, between Polson and Howard Streets, San Francisco. Paving blocks forced up into sharp arches and dislodged by compression. H. O. W.

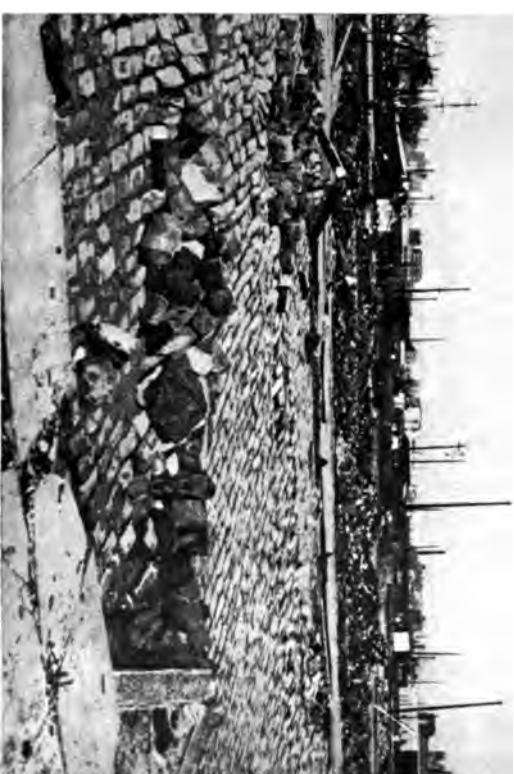
D. Moss Street, between Polson and Howard Streets, San Francisco. Paving blocks arched by compression along sinuous crest, curling thrown into an inverted V. H. O. W.

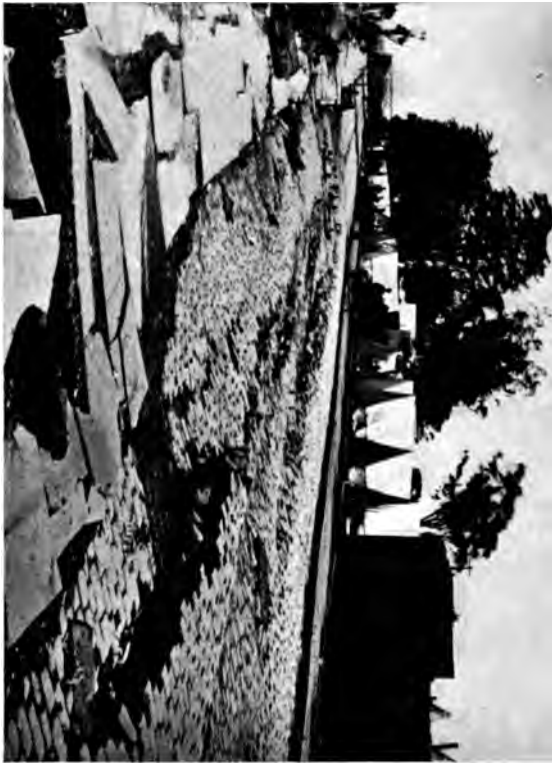
A. Columbia Street, just south of Tolson Street, San Francisco. Slumping, depression, and furrowing of block pavement. H. O. W.

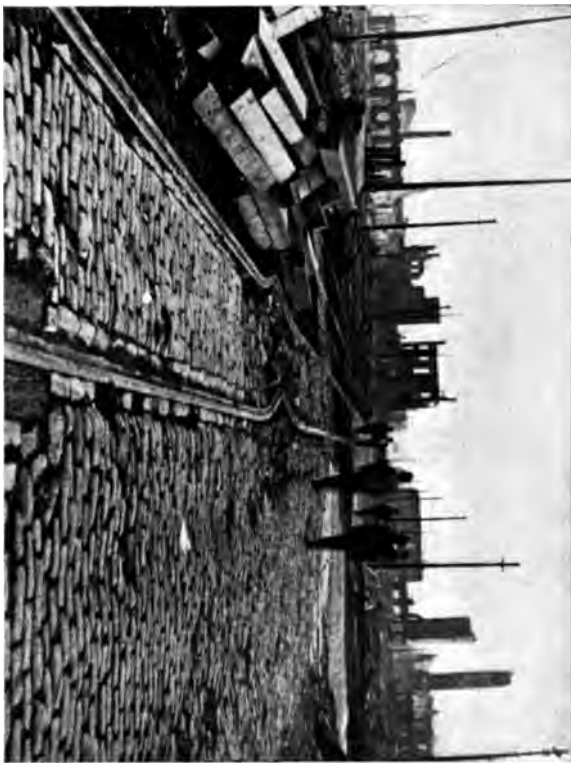
B. Bryant Street, near Fourth Street, San Francisco. Flexure of heavily ballasted car tracks in block pavement; an effect of sharp compression. H. O. W.

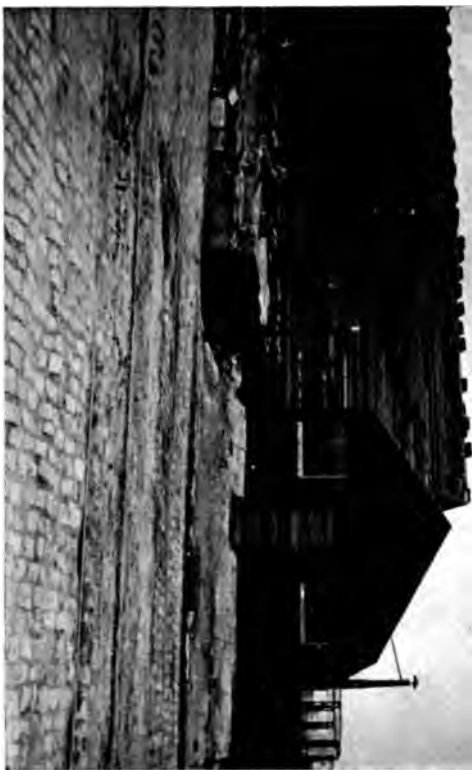
C. Sixth Street, near Howard. Once occupied by marsh. Street drop nearly 3 feet. Sidewalk held up by piling foundation of a building. H. O. W.

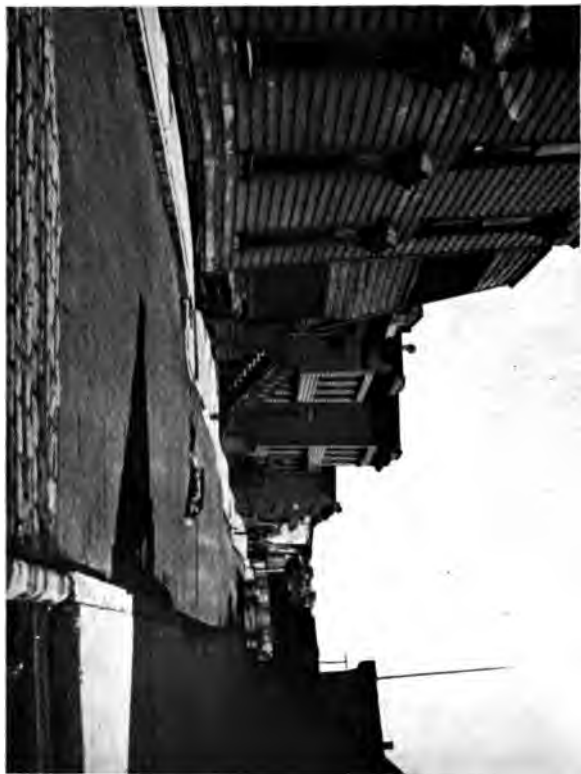
D. Looking along Dore Street, from Bryant toward Brannan. Undulating and fractured condition of pavement due to earthquake. Houses thrown off their underpinning and pitched out of the vertical. H. O. W.

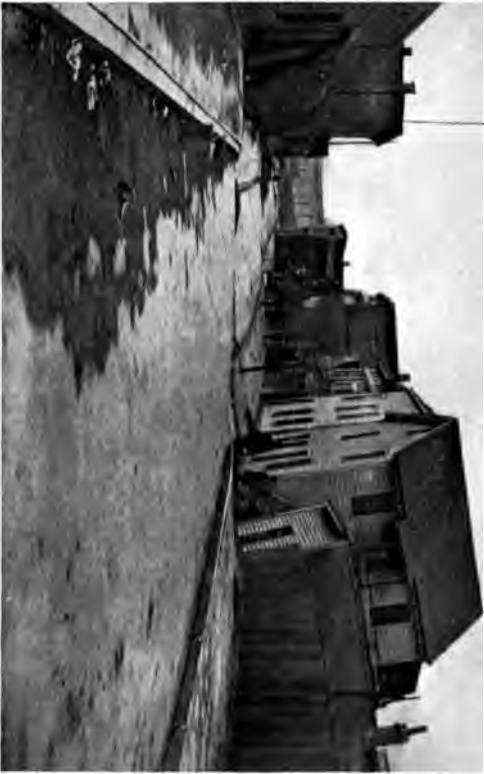
A. Looking along Dore Street from Brannan toward Bryant. Larger undulations near Brannan. Dore Street is on site of an arm of Mission Creek. H. O. W.

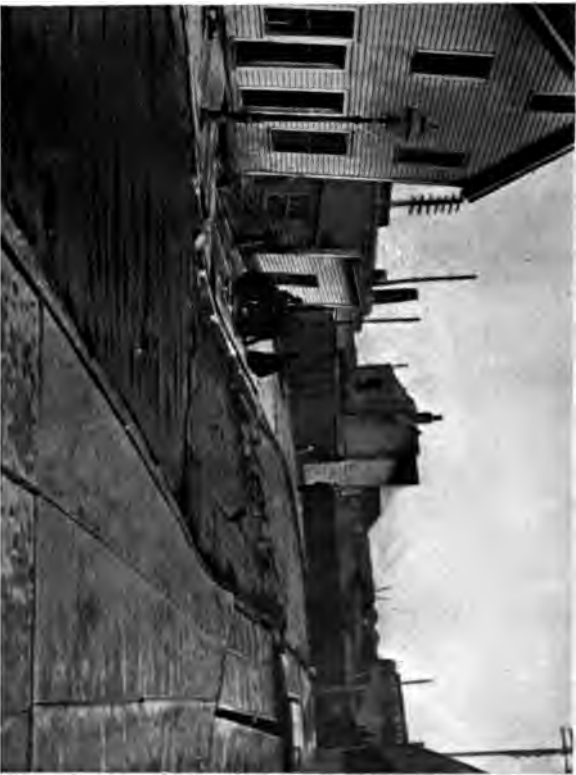
B. Dore Street, near Brannan. Vertical difference between crest and trough of undulations, 5 feet. H. O. W.

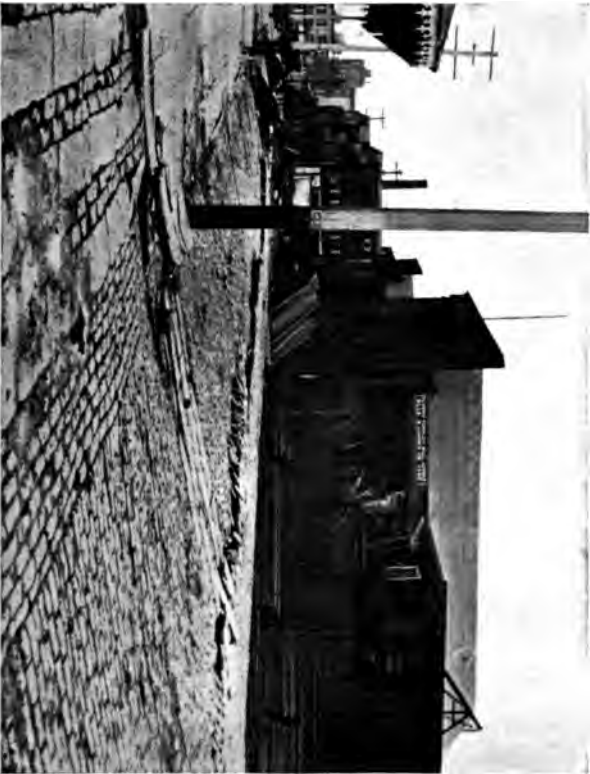
C. Eighteenth Street, just east of Shotwell. Fishtailing and depression of pavement. H. O. W.

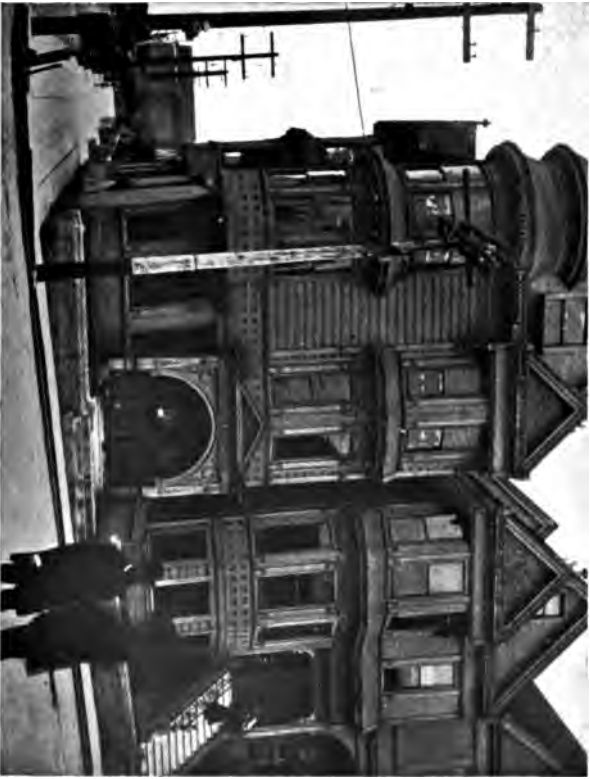
D. Southwest corner Portola and Waller Streets. Buildings have shifted down hill slightly, upper parts more than lower. H. O. W.

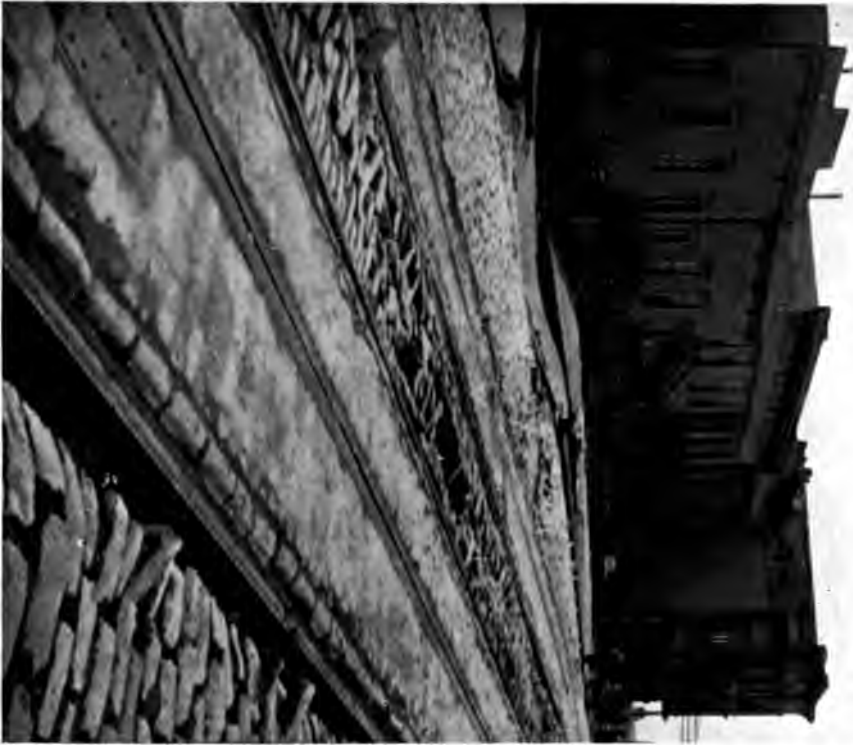
**A. Ninth Street, between Bryant and Brannan. Undulation and flexing of pavement and sidewalk. Houses over trough have been dropt from their underpinning. G. K. G.**

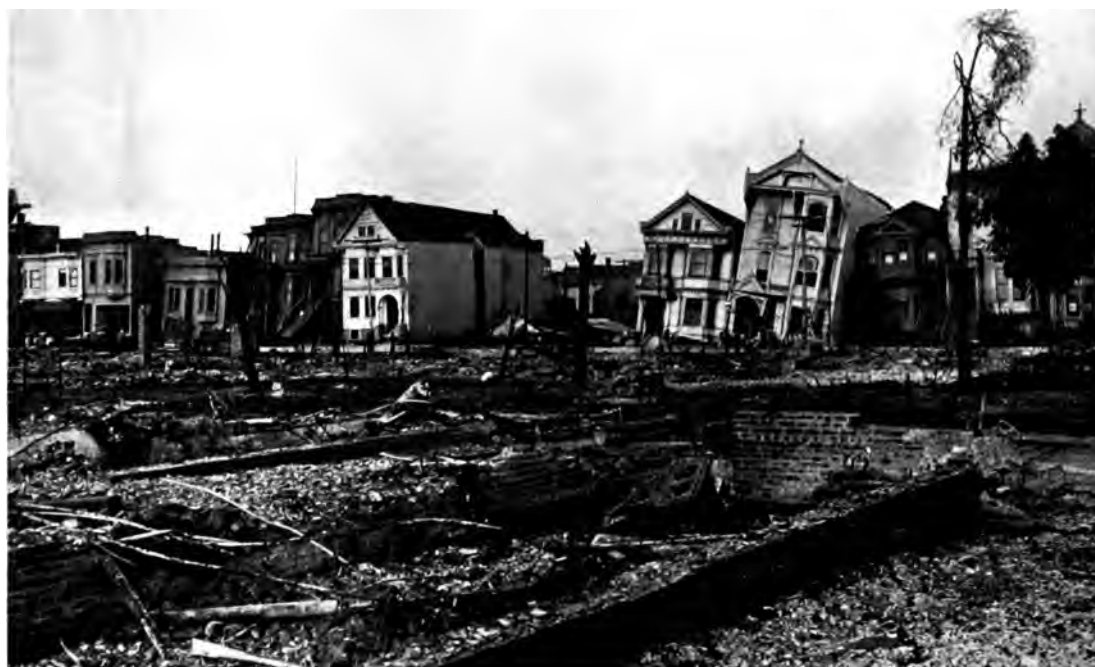
A. East side of Howard Street, between Seventeenth and Eighteenth Streets. A. C. L.

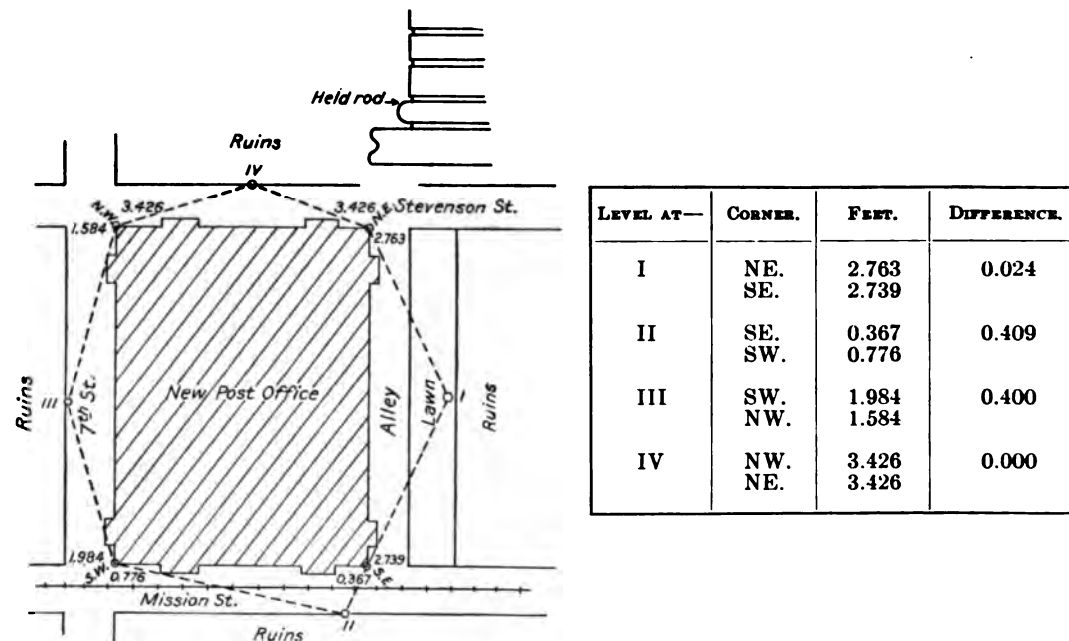
*New Post-office.* — Fig. 52 shows by numbers the positions of the stations occupied; and the points at the corners, the relative levels of which were determined, are indicated by their orientation.

The southwest corner is the lowest and is the only one that settled materially, being about 0.393 foot = 4.72 inches lower. The outer walls have cracks in many places. This is a fairly good showing for a bad foundation.

FIG. 52. — Map showing relative levels of four corners of new Post-office, San Francisco.

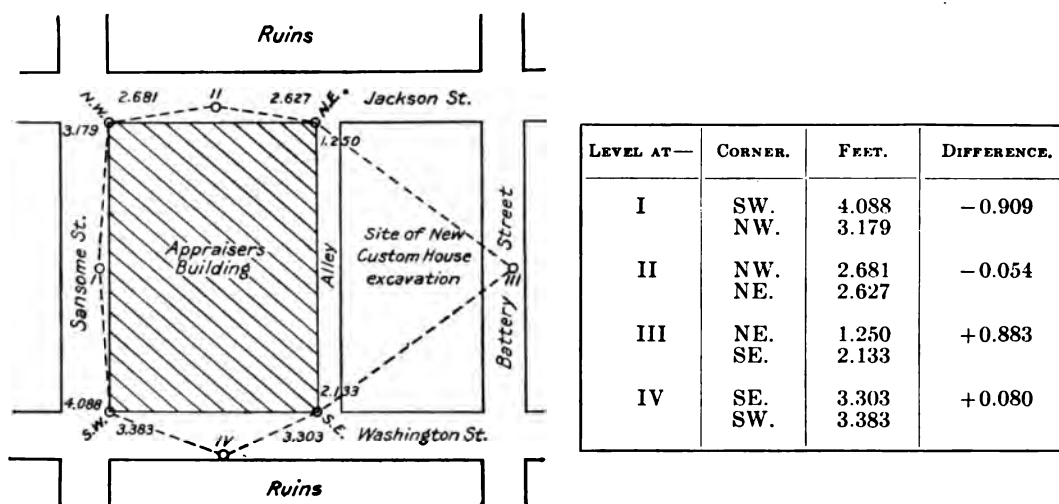
*Appraisers' Building.* — Fig. 53 shows by numbers the position of the stations occupied; and the points at the corners are indicated, as before, by their orientation.

The northwest corner is 0.909 foot = 10.908 inches above the southwest corner. The northeast corner is 0.909 foot + 0.054 = 0.963 foot = 11.556 inches above the southwest corner. The southeast corner is 0.080 foot = 0.96 inch above the southwest corner. The rod was held on top of water-table at each of the four corners, and the sights were nearly equal in length. The south side of the building is about 11.23 inches lower than the north side.

FIG. 53.—Map showing relative levels of four corners of Appraisers' Building, San Francisco.

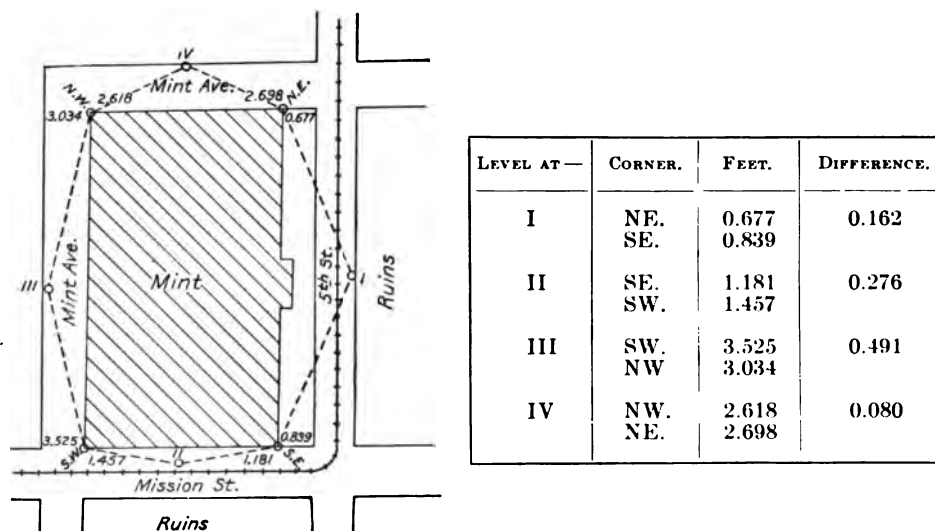
*Mint.* — Fig. 54 shows by number, as in the former cases, the positions of the stations occupied and the points at the corners are indicated by their orientation.

The southwest corner is the lowest, being 0.498 foot = 5.976 inches (mean) below the northwest corner. The walls on the north side are badly scaled by the heat. No serious cracks were noticed in the outside. The rod was held on top of the water-table at each extreme corner of the building. Street cars constantly passing on both Mission and Fifth Streets, also heavy drays. The wind was very troublesome. Sights were nearly equal.

FIG. 54.—Map showing relative levels of four corners of Mint, San Francisco.

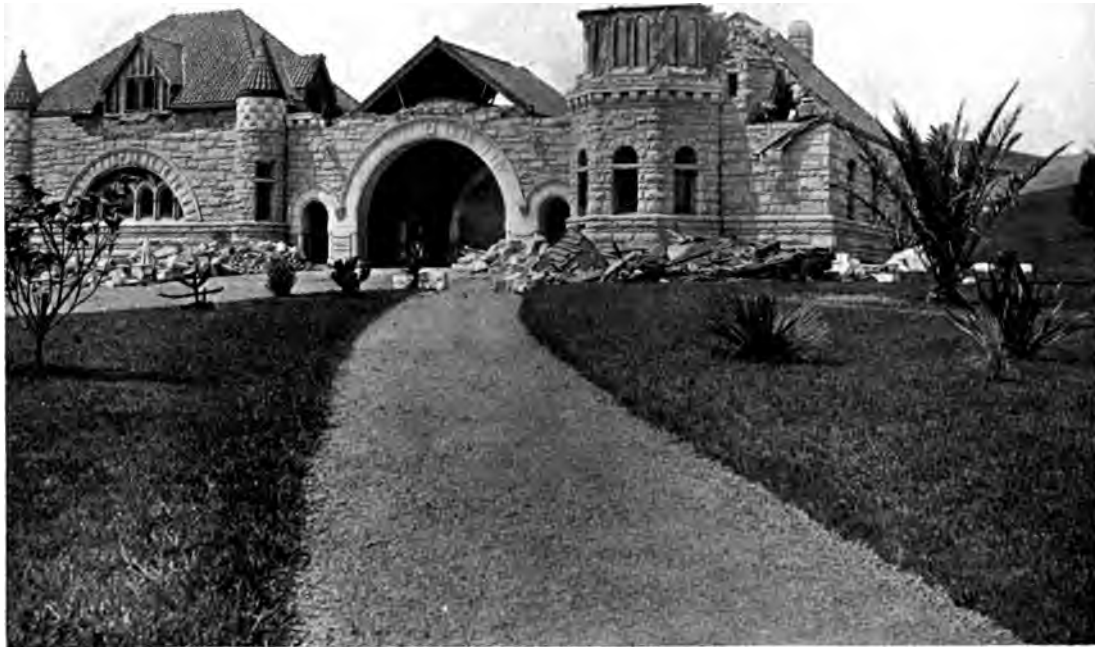
A. Woodlawn Cemetery, south of San Francisco. A. C. L.

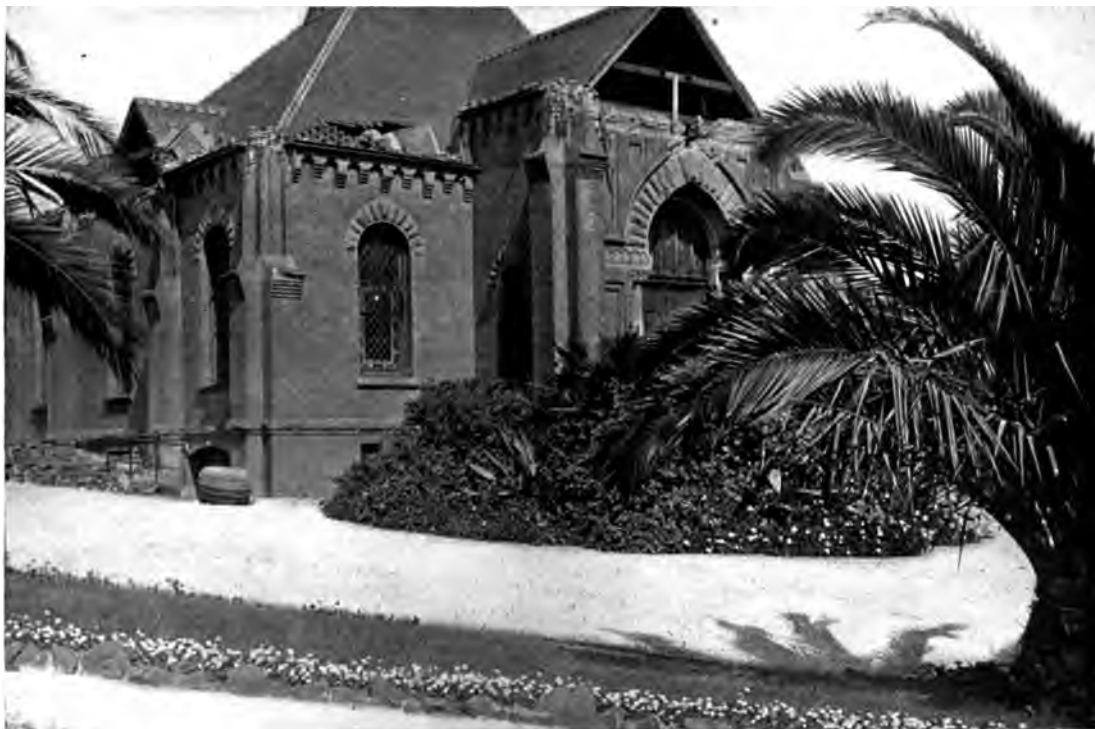
B. Hills of Eternity Cemetery, south of San Francisco. All four gables thrown out. Parapets thrown in on roof. A. C. L.

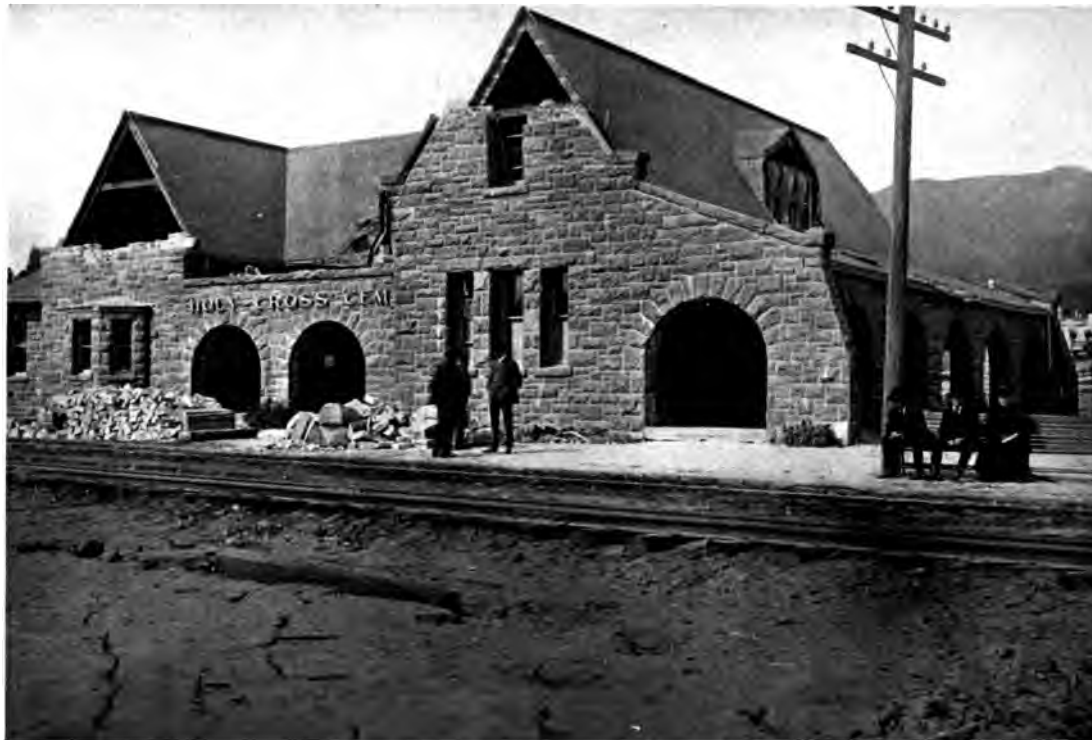
A. Holy Cross Cemetery Station, south of San Francisco. Building on made ground. A. C. L.

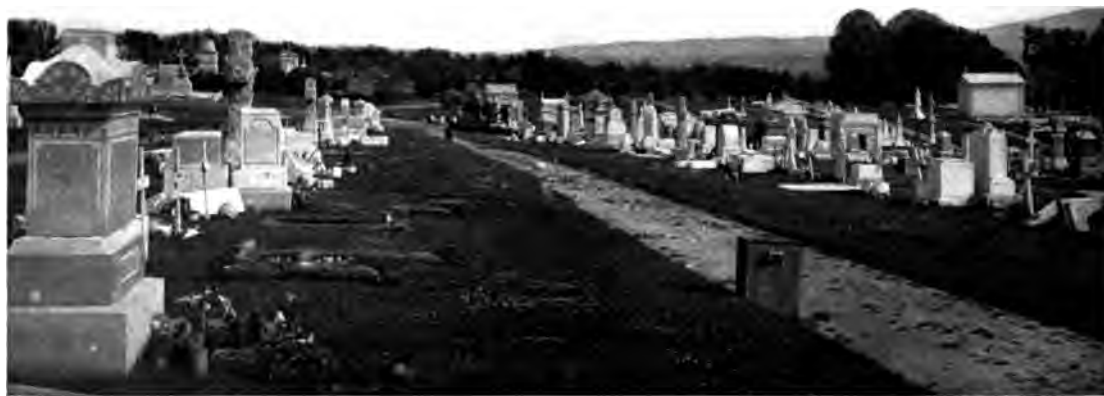
B. Holy Cross Cemetery, south of San Francisco. A. C. L.

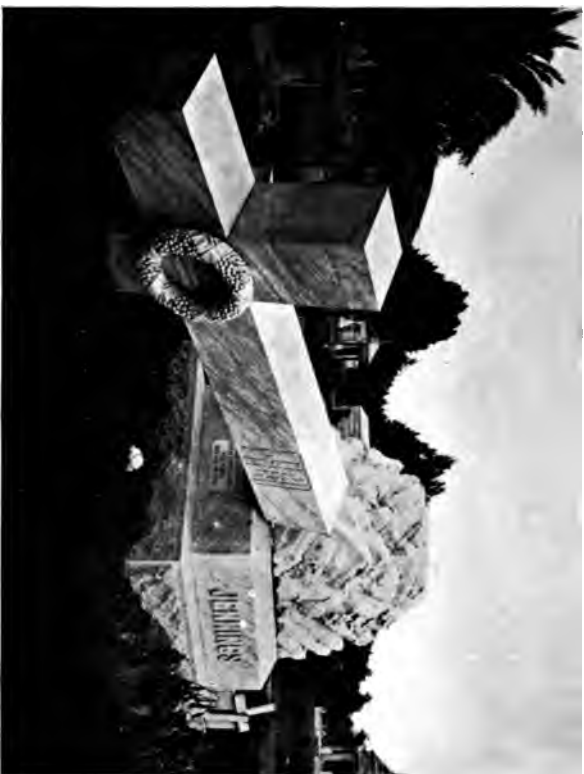
A. Overthrown monument, Holy Cross Cemetery. R. B. M.

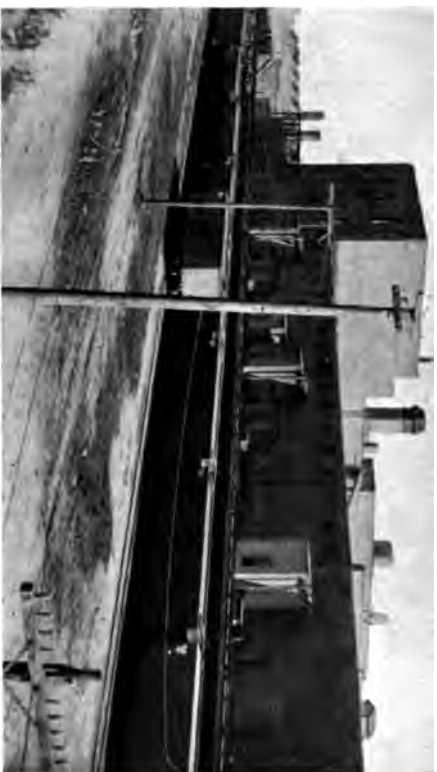
B. Brick building and high chimney left standing. South San Francisco. R. B. M.

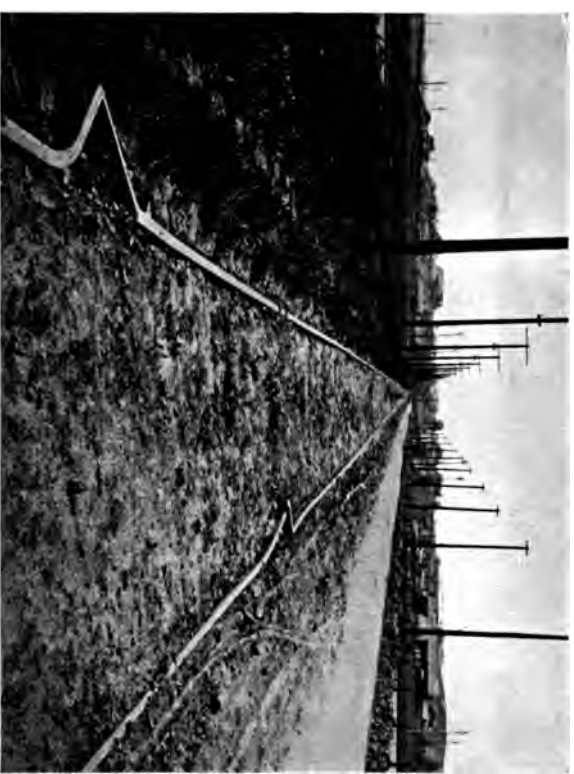
C. Roadbed and rails of electric railway on marsh west of San Bruno. R. B. M.

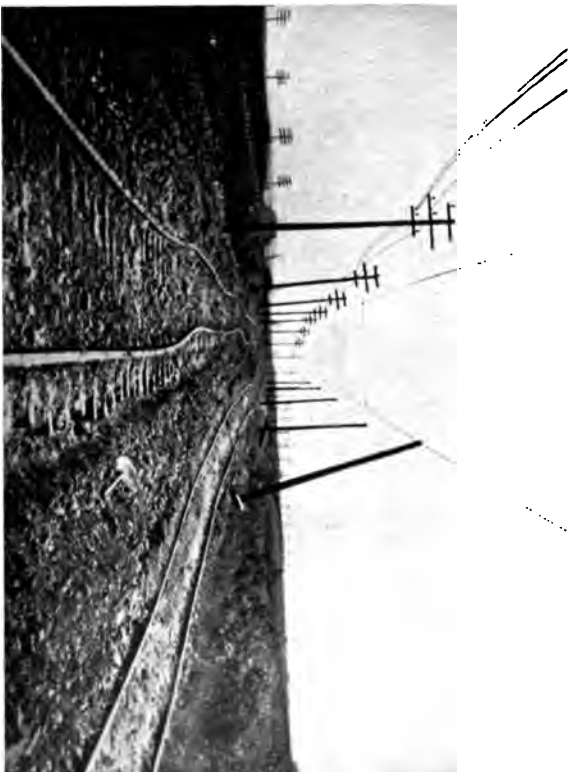
D. Roadbed and rails of electric railway between Baden and San Bruno. R. B. M.

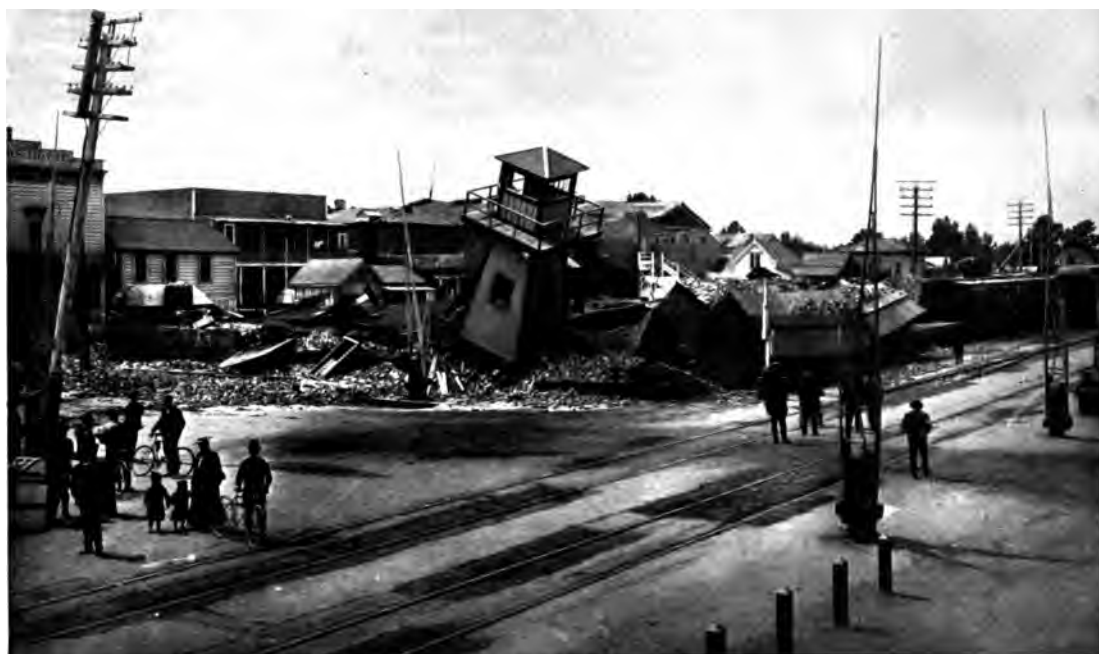
A. Wreck of 1-story brick railway warehouse, San Mateo. Per J. O. B.

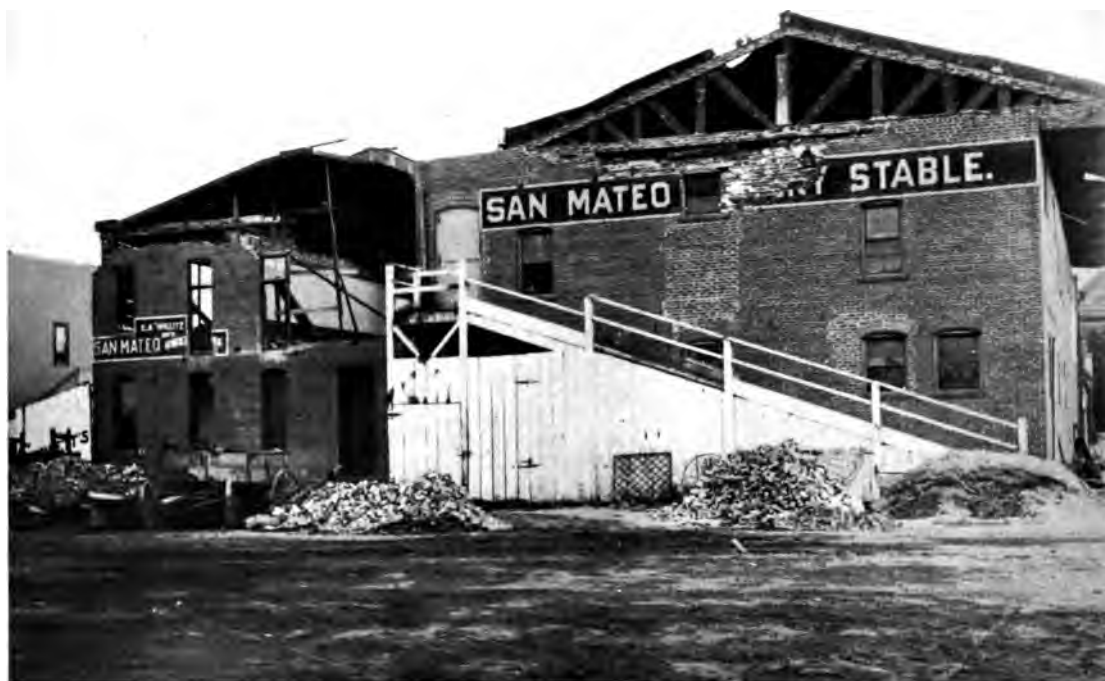
B. Brick stable, San Mateo. Upper story was thrown out and roof dropt one story. Per J. O. B.
